Technical Report CHL-97-17 August 1997

Periodic Inspection of Humboldt Bay Jetties, Eureka, California

Report 1 Base Conditions

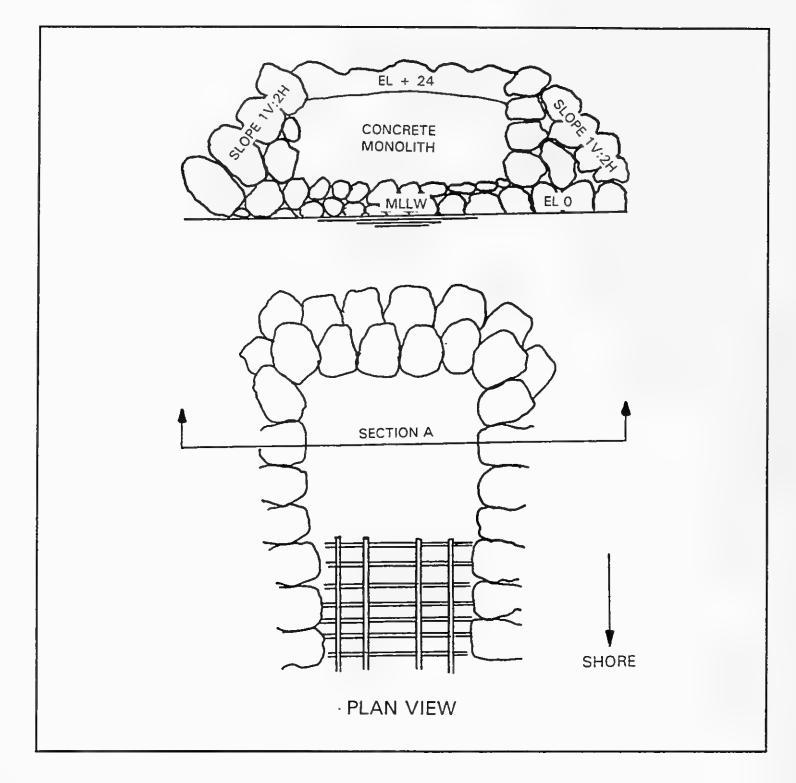
Figure 2. Concrete monolith structure constructed on south jetty in 1911

The head of the south jetty, which had been subjected to some of the most severe damage, was reinforced with a concrete monolith that was 9.1 m (30 ft) wide and 4.3 m (14 ft) deep (Figure 2). The 861,825-kg (950-ton) monolith was placed in the center of the head and armor stones up to 18,140 kg (20 tons) were laid up adjacent to the monolith. The el of the head was raised to +7.3 m (+24 ft) and the voids between the armor stones were filled with stones of not less than 227 kg (500 lb) in weight.

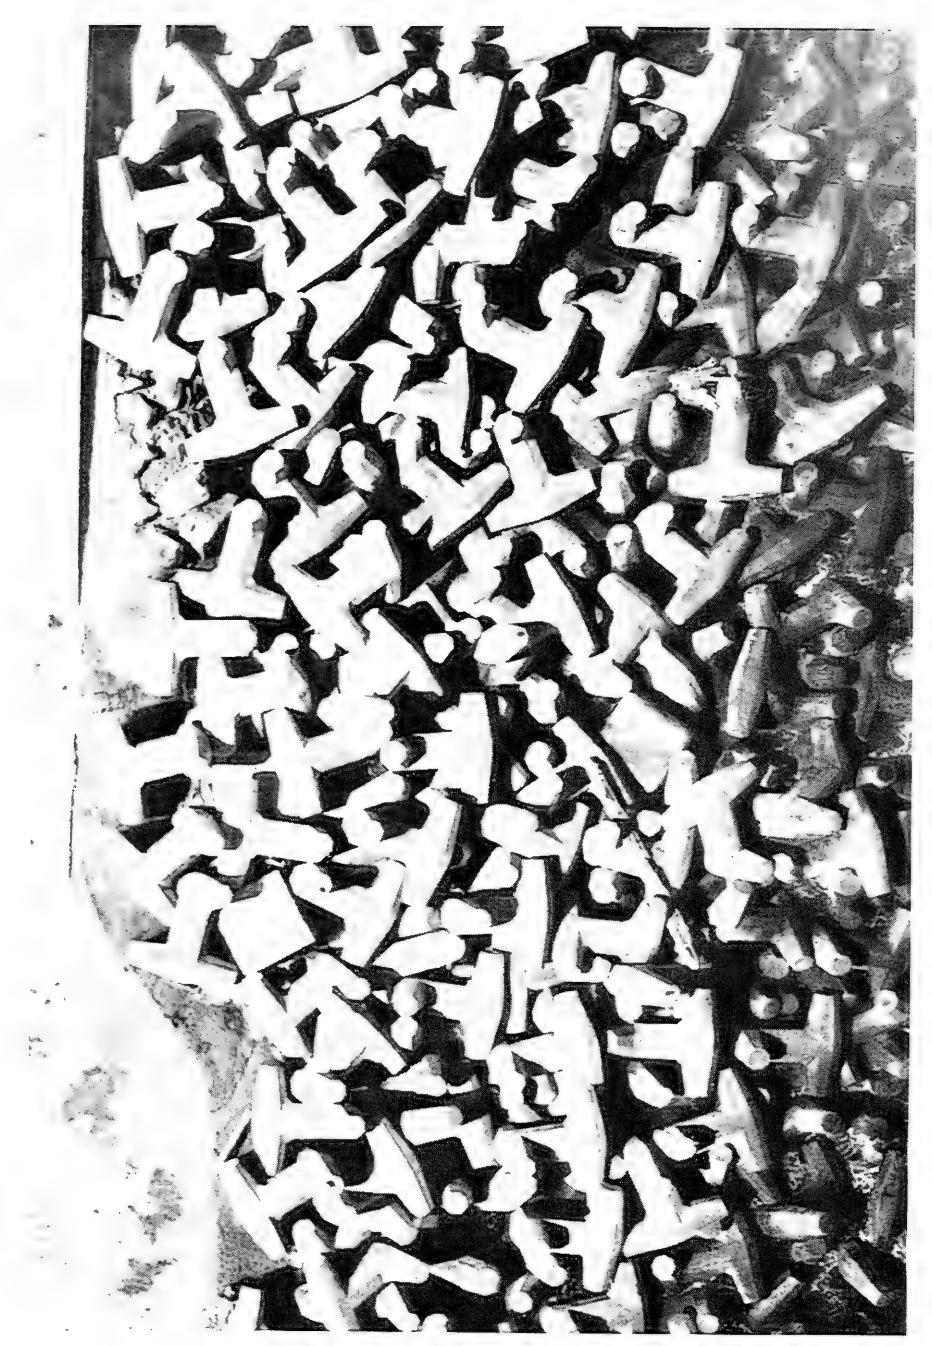
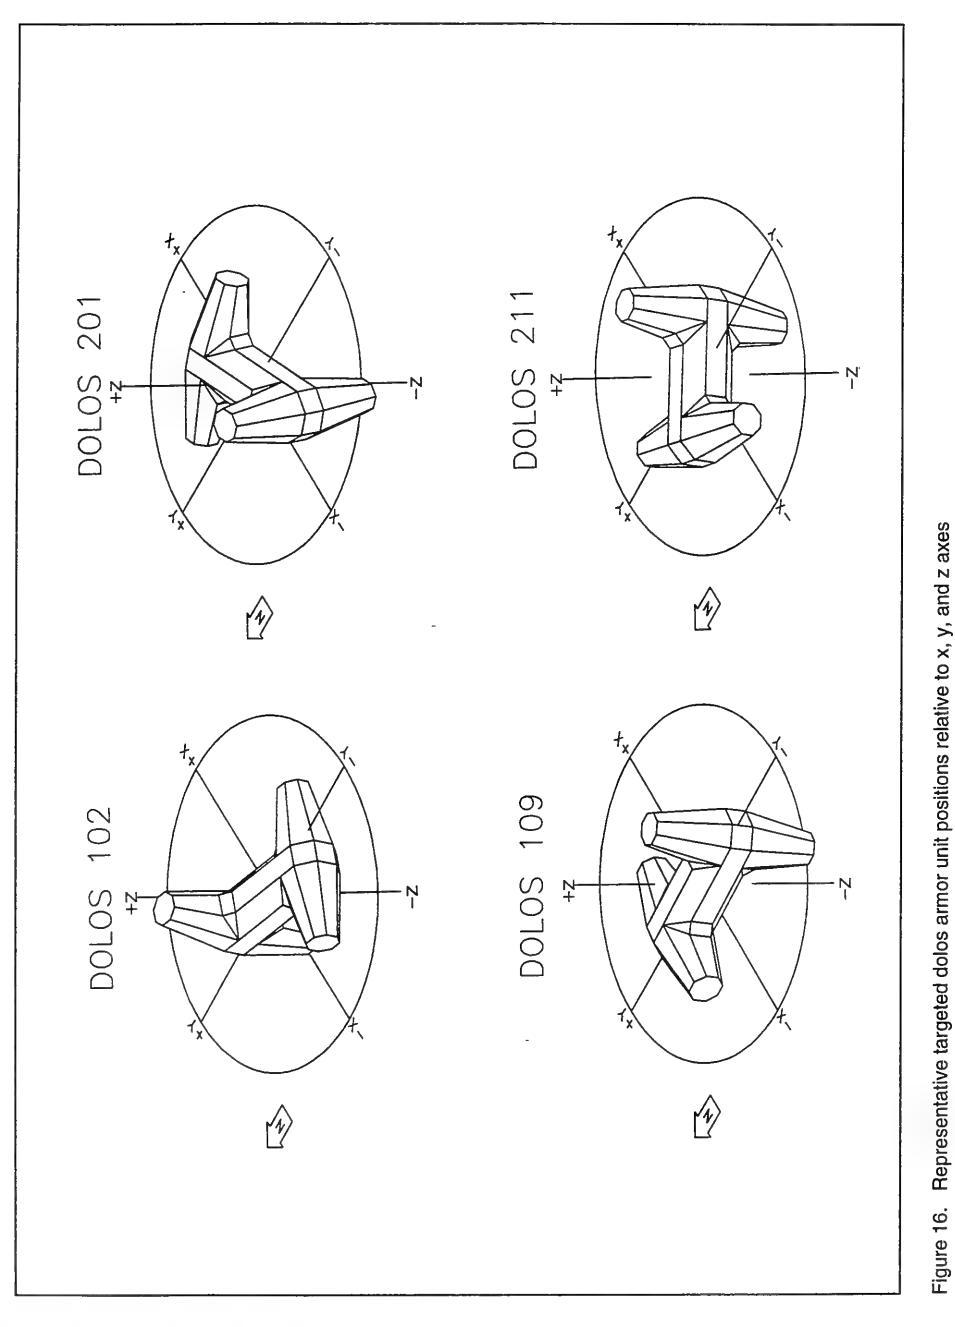
approximate center line of the structure. At the heads of the structures the baselines were projected seaward along the axis of the jetties. Thirty-four broken or cracked dolosse (seventeen on each jetty) were identified during the walking survey. Armor units with hairline cracks on one side were not counted; only those that were cracked all the way through were considered a break for recording purposes. Breaks were categorized as occurring in the shank or the fluke and as straight across or at some angle to the dolos limb. The shank is the central beam of a dolos, and the flukes are the beams on the ends of the armor unit. The broken units on the north jetty consisted of seven mid-shank breaks, eight shank-fluke breaks (shank broken in vicinity of fluke), and five fluke-shank breaks (fluke broken in vicinity of shank). One unit had two breaks: eight units, shank-fluke breaks; and seven units, fluke-shank breaks. Of the 35 breaks, 27 were straight breaks and 8 were angled breaks (approximately 45 deg or greater). Representative broken dolosse are shown in Figures 17-20.

Approximate locations of the broken/cracked dolos armor units are shown in Figures 21 and 22, respectively, for the north and south jetties; and detailed data obtained during the broken armor unit inventory are shown in Table 4. Armor unit numbers identified in Figures 21 and 22 correspond to those listed in Table 4. As shown on the figures, broken units are concentrated along the seaward ends of the jetties. Eighty-eight percent of the broken units on the north jetty and seventy-one percent of those on the south jetty are located around the monolithic structures at the jetty heads. In addition, more broken dolosse were observed on the south sides of the structures than on the north. If the approximate center lines of the jetties are projected seaward along the axes of the structures, 59 percent of the broken units on the north jetty and 65 percent of those on the south jetty are located on the south regard to distance downslope from the jetty caps, most the broken dolosse appear to be located in the active wave zone. Detailed data obtained during the broken armor unit survey will allow for an accurate indication of new breaks when the structure is revisited at some point in the future.
